USDOT Tier 1 University Transportation Center Final Report

NURail Project No. # NURail2012-UKY-R03 and NURail2013-UKY-R06

## **3D Methodology for Evaluating Rail Crossing Roughness**

02 March 2015

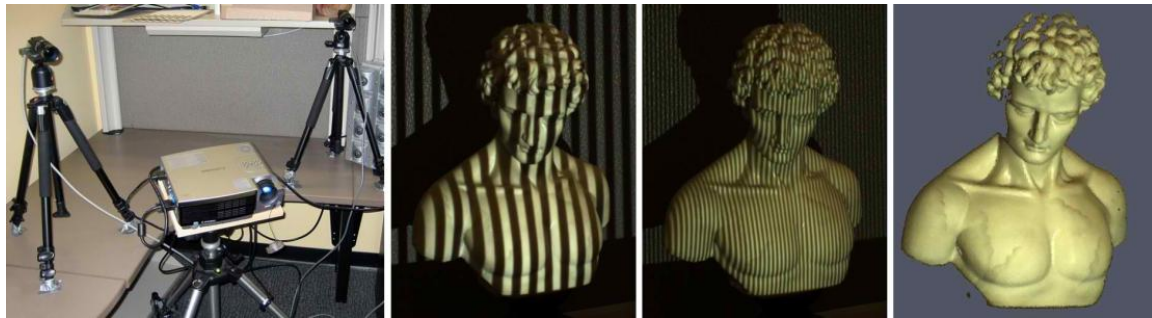
Another 3D imaging technology known as structured light 3D scanning uses projected light patterns and a high resolution digital camera system to measure the shape, depth and surface information of an object. A known pattern of pixels (light strip) is distorted when projected on a non-flat surface. From recording of this information, depth and shape of the object may be calculated [13] [14]. A structured light 3D scanner can provide scan data at very high accuracy (sub-centimeter) with a relatively low investment of about \$5,000 in equipment.

Figure 5. Structured light

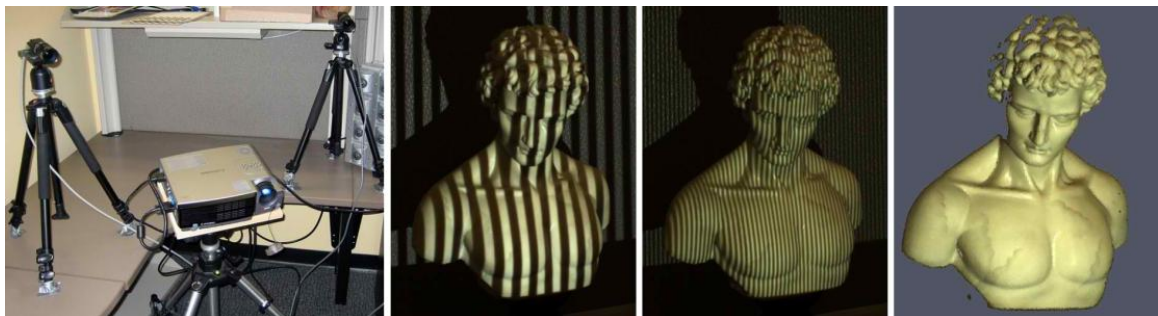
A low-cost 3D imaging technology (structured light 3D scanning) uses projected light patterns and a high resolution digital camera system to measure the shape, depth and surface information of an object as shown in figure 1. A known pattern of pixels (light strip) is distorted when projected on a non-flat surface. From recording of this information, depth and shape of the object may be calculated [10] [11]. A structured light 3D scanner can provide scan data at very high accuracy (sub-centimeter) with a relatively low investment of about \$5,000 in equipment.

Figure 1. 3D Structured light scanner [12],[13]

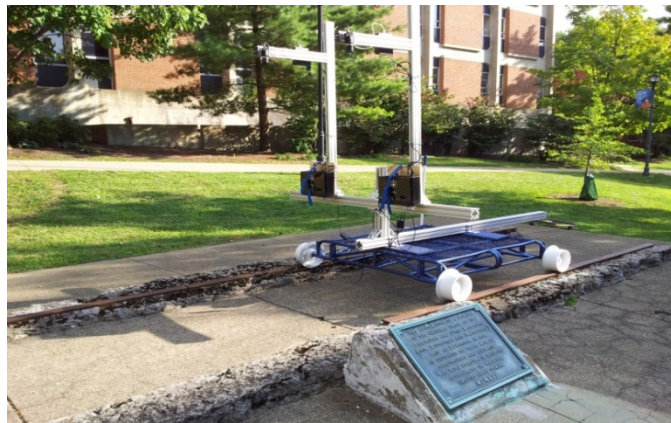
As a scanner platform, a rail cart was built to include a frame with wheels, a laptop computer with structured light data capturing software, an 1100 watt AC/DC converter, power cables and power provided by the battery of a test vehicle as shown in figure 3.

Figure 3. DAS prototype

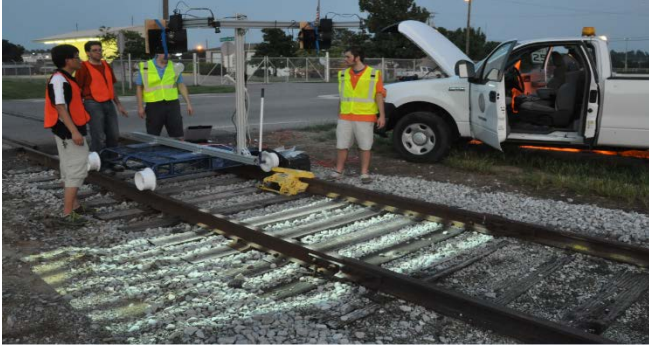
Several field tests have been conducted at crossings around Lexington, KY and at the site of the Bluegrass Railroad Museum in Versailles, KY. Figure 5 pictured one field test at crossing (USDOT 719862A) on Beasley Rd. Versailles, KY. There was one scanner mounted at each end of the beam of the DAS. Each scanner took one scan of one side of the crossing alternatively to avoid light pattern across each other. In the end, there were total 52 scans collected for this crossing. The test took about 2 hours. During the scanning process, each scan had 6'x10.2' in size and one foot overlapped area in the longitudinal direction with the other scans before and after it. Two scanned 3D points clouds were shown in figure 6.

Figure 5. Field Test at crossing (USDOT 719862A) on Beasley Rd. Versailles, KY

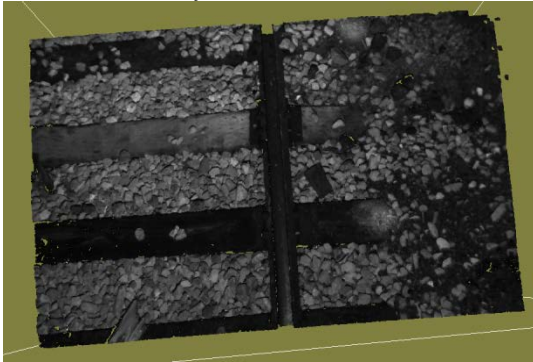
Figure 6. . Sample of data collected in the field

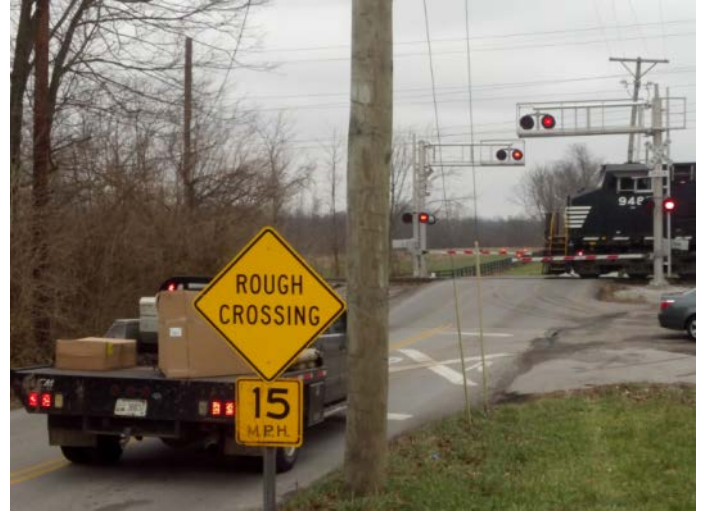
Figure 2. Brannon Rd Crossing

The crossing is generally rough as can be seen in elevation changes on the highway approaches as depicted in Figures 2 and 3.

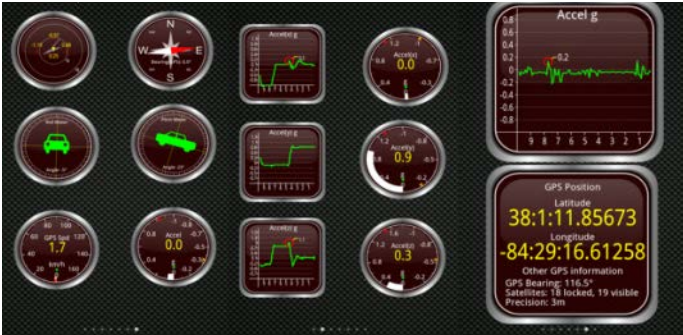
The test vehicle chosen was a 2009 Chevrolet Impala sedan. Other equipment and devices used in field tests included 1) a real time acceleration sensor from PASCO model number PS-2119 which records and stores 3 axis (XYZ) acceleration data at 100 hertz with the range of +/- 10 g, accuracy +/- 1% and resolution at 0.010 g, 2) a laptop PC preloaded with PASCO real time recording software, 3) a smart phone with built-in A-GPS that records and stores the GPS coordinates and vehicle speed at 1 hertz (see Figure 4), and, 4) a stop watch. Both the acceleration sensor and smart phone were mounted on the center of the dashboard of the vehicle during the test.

Figure 4. Smart phone GPS user face.

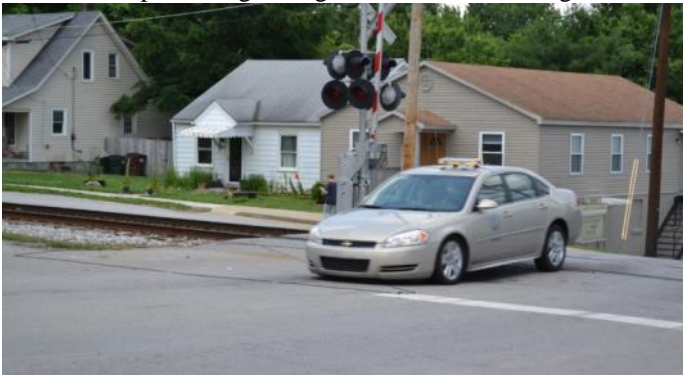
Two students performed the test, a driver who tried to drive at a constant speed over the crossing and a passenger recording the time before and after passing the crossing, referencing a fixed objective such as a tree or light pole. The acceleration sensor and GPS were kept running during the entire test. See Figure 5.

Figure 5. Field acceleration data collection.

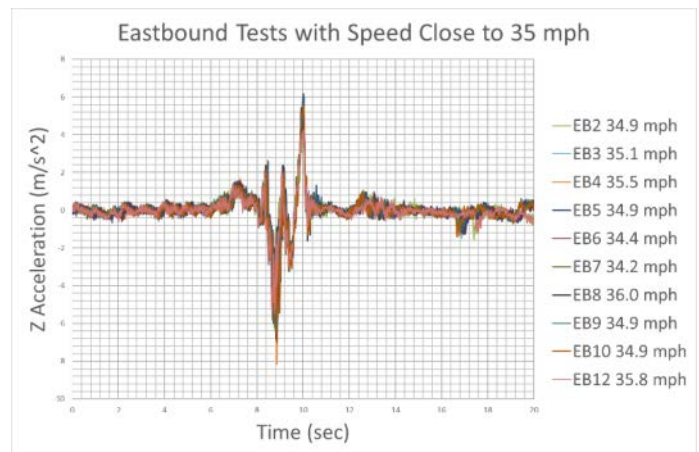
For each of the eastbound and westbound groups, 10 tests with speeds close to 35 mph were selected. Results are shown in Figures 8 and 9.

Figure 8. Eastbound tests with speed close to 35 mph.

Figures 8 and 9 both show that when the test speed is held constant (35 mph), both the frequency and amplitude of acceleration from one test are very close. This indicates that the test is highly repeatable and method is reliable for future work.

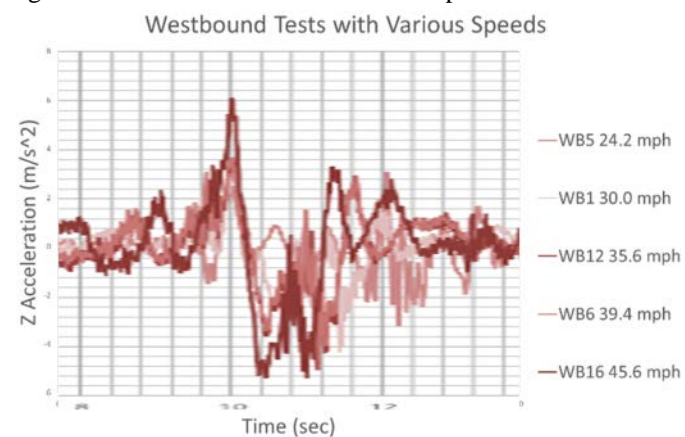
To test the effect of speed variation on accelerations, several tests were performed at various speeds in both directions. Results of these tests are shown in Figures 10 and 11. Note that in the plots, darker shades indicate higher speeds.

Figure 11. Westbound tests with various speeds.

From Figures 10 and 11, it can be seen that as expected, acceleration amplitudes and frequencies increase with increasing speeds.

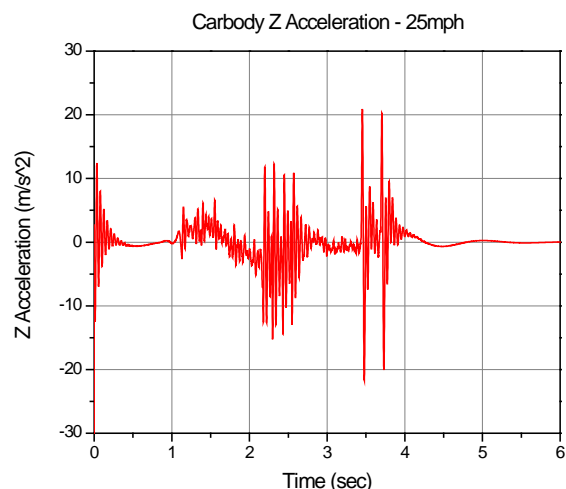
Figure 12. Initial results of a vehicle dynamic model for Brannon Crossing, 25mph (uncalibrated)
